Grasse River Superfund Site

Public Meeting

October 30, 2012 7:00 PM

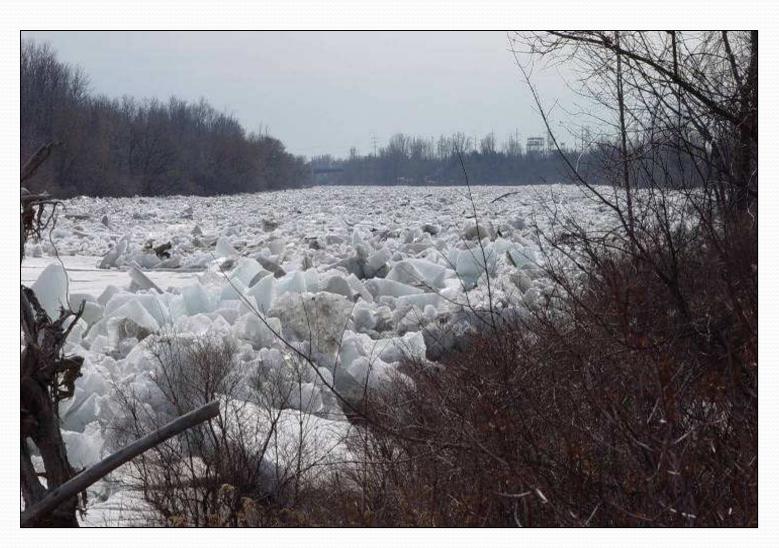
March 2003 Ice Run Photo: Grasse River

- From 1991 to 2010, numerous studies were conducted to define the extent of contamination and to develop the alternatives for cleanup
- Several pilot studies and demonstration projects of various technologies also conducted in the river
- During post implementation monitoring of the capping pilot study, "ice jam" event severe enough to scour sediment was discovered

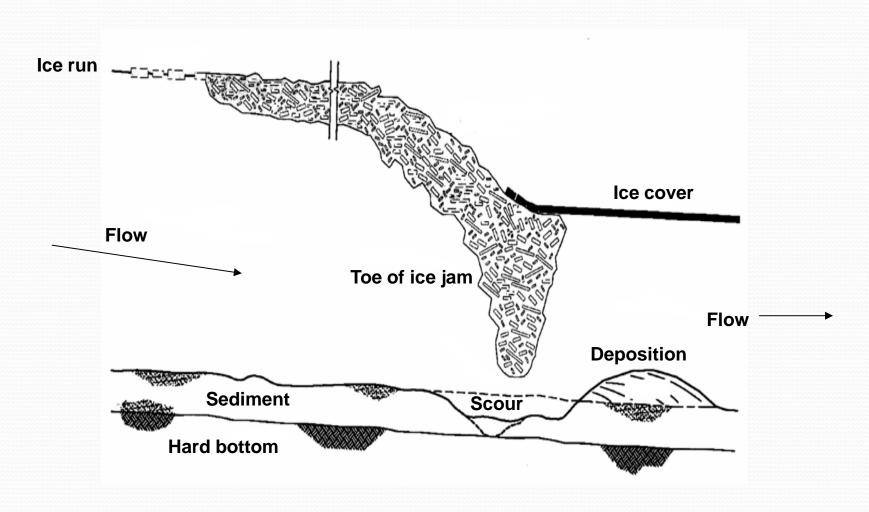
Profile of Ice Jam

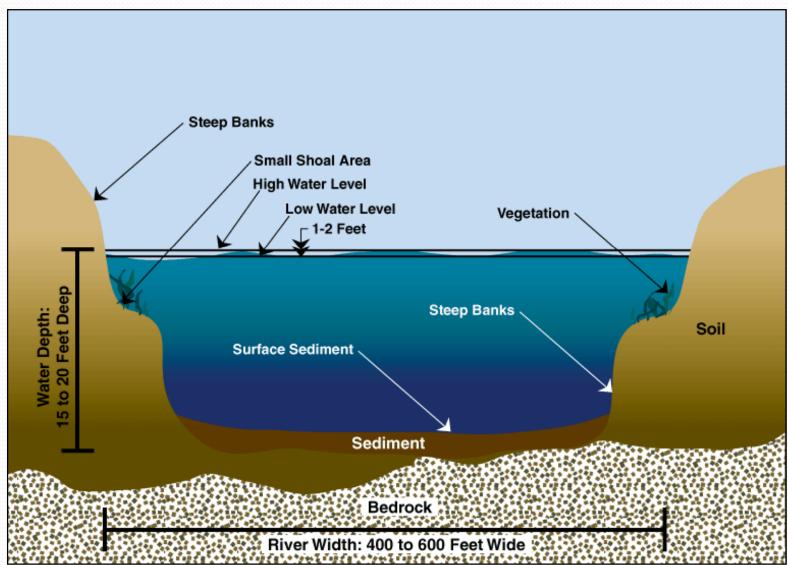
Grasse River Profile

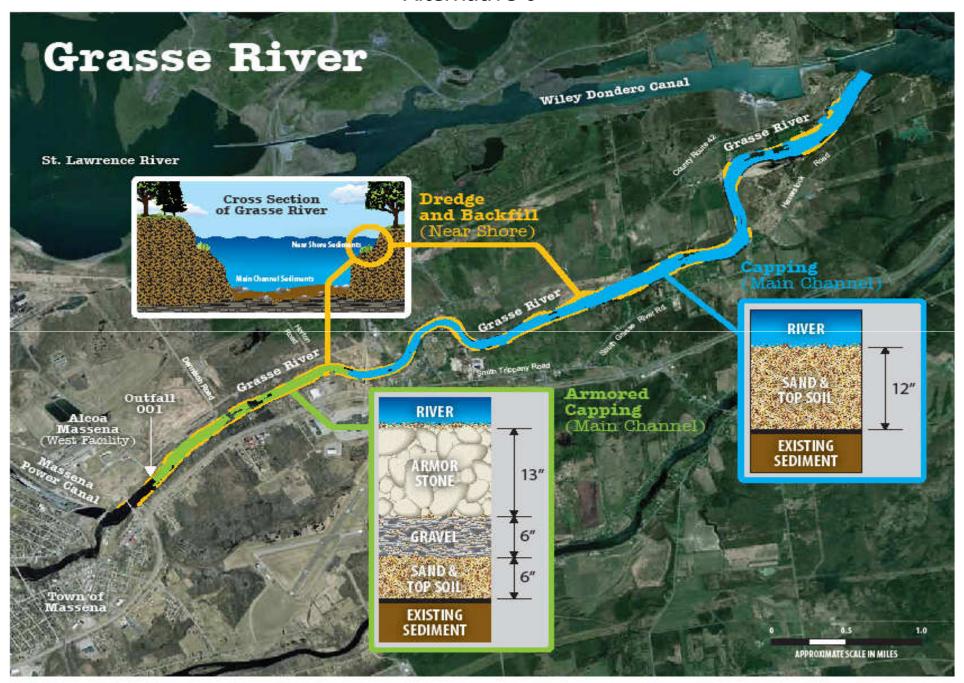
Alternative 6

- Dredge near shore sediment PCB concentrations ≥ 1 parts per million (ppm), followed by backfill to grade (approx. 109,000 cubic yards)
- Place main channel armored cap over T1-T21 main channel sediments where either the segment length weighted average (SLWA) or the maximum surface sediment PCB concentrations ≥ 1 ppm (approx. 59 acres)
- Place main channel cap over T21-T72 main channel sediments where the maximum surface sediment PCB concentrations ≥ 1 ppm (approx. 225 acres)
- Dewater dredged sediment and dispose in the on-site permitted landfill
- Reconstruct habitat impacted by remedial action
- Long-term monitoring and maintenance
